## **ASSESSING THE RELIABILITY OF EXISTING ANCHOR INSTALLATIONS AT LOCH ALVA AND LOG FALLS DAMS**

Gregory Snyder, P.Eng., Hatch Energy, Fredericton, New Brunswick, Canada  
Doug McEwen, P.Eng., Hatch Energy, Niagara Falls, Ontario, Canada  
Bethanie Parker, M.Eng., P.Eng., Hatch Energy, Fredericton, New Brunswick, Canada  
Rick Donnelly, M.Eng., P.Eng., Hatch Energy, Niagara Falls, Ontario, Canada  
Robert Murray, P.Eng., Government of New Brunswick, Fredericton, New Brunswick, Canada

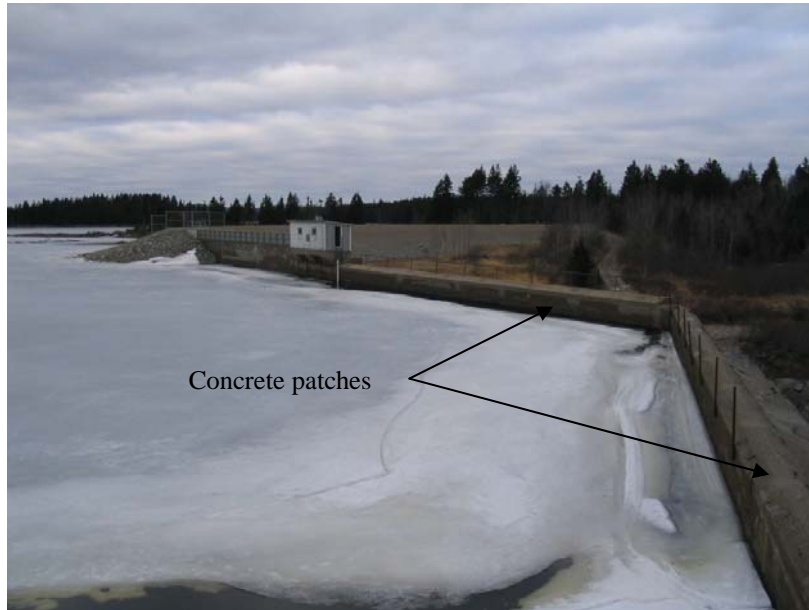
Figure 3: Concrete Patches Visible At Log Falls Dam Prior To Investigations

The condition assessment of the Loch Alva and Log Falls structures found that there was physical evidence of existing rock anchors: concrete patches were visible at both dams. A background search of existing drawings found details of bar anchors installed in the gravity section and gate house section of Log Falls Dam in 1964 but no details of anchors in the spillway sections of the Log Falls Dam nor any details of the anchors at Loch Alva Dam were found. Figure 3 shows the concrete patches at Log Falls Dam.

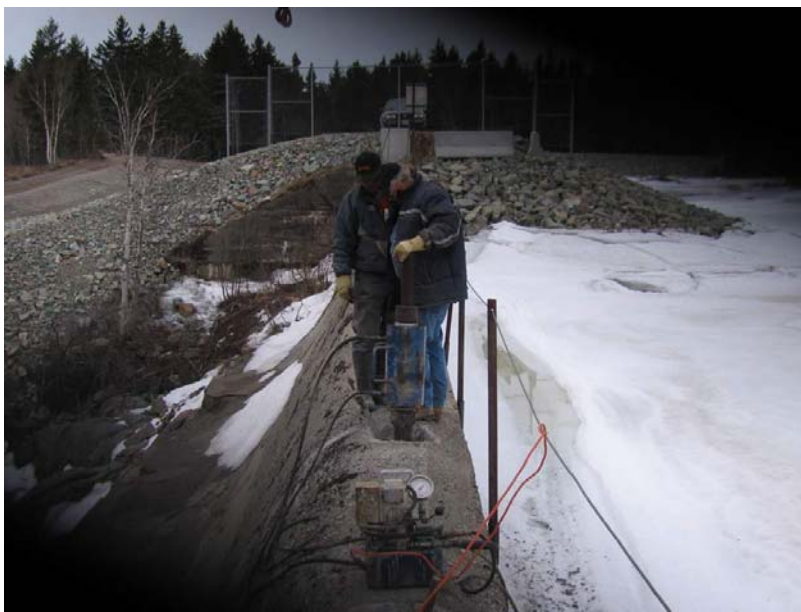
Figure 4: Lift-Off Test in Progress at Log Falls Dam

Lift-off testing was then performed on all twelve anchors to determine the residual loading on the anchors. The results of the lift-off tests are summarized in Table 3. A photograph of the equipment used to perform the tests is shown in Figure 4. The preparation for the lift-off testing had to consider the possibility that the anchors could be fully grouted with the grout adhering to the anchor. If that were the case, then the stretching of the anchor during the test would only occur at the very top of the anchor. With the condition of the anchors unknown, the possibility of anchor failure during the testing had to be prepared for.

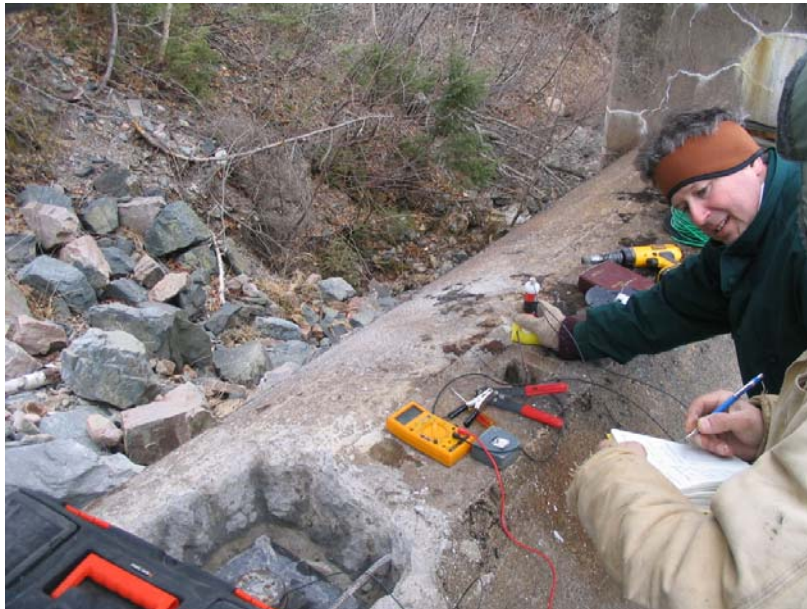
Figure 5: Half-Cell Potential Measurement in Progress

- **Half-Cell Potential Measurement:** Half-cell potentials ( $E_{\text{corr}}$ ) indicate that the grout is effectively passivating the anchors. For some of the tested anchors, there is an apparent shift in the potentials towards the uncertain range relative to corrosion, but the readings do not appear to be unusually low (i.e. more negative than -350 mV). A photograph taken during a half-cell potential measurement at Loch Alva Dam is shown in Figure 5.

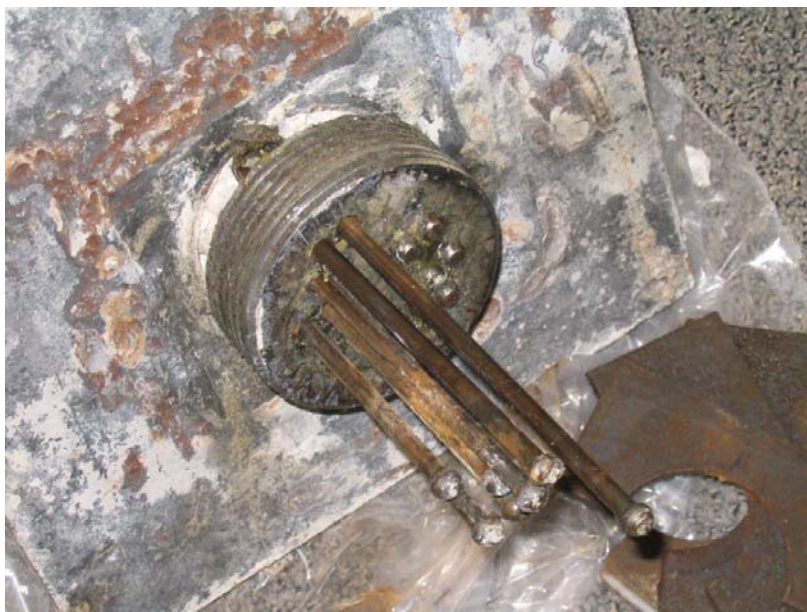
Figure 6: Dismantled Head of Multi-Wire Anchor

Various recommendations were made by MMCE including ongoing monitoring and the removal of the head assembly from at least one of the wire-type anchors to determine the condition of the wires within the anchor head. It was decided to remove four, two from each dam, and it was found that all of the wires were greased within the heads and that the grease was in tact with no signs of corrosion of the wires. One of the dismantled heads is shown in Figure 6.

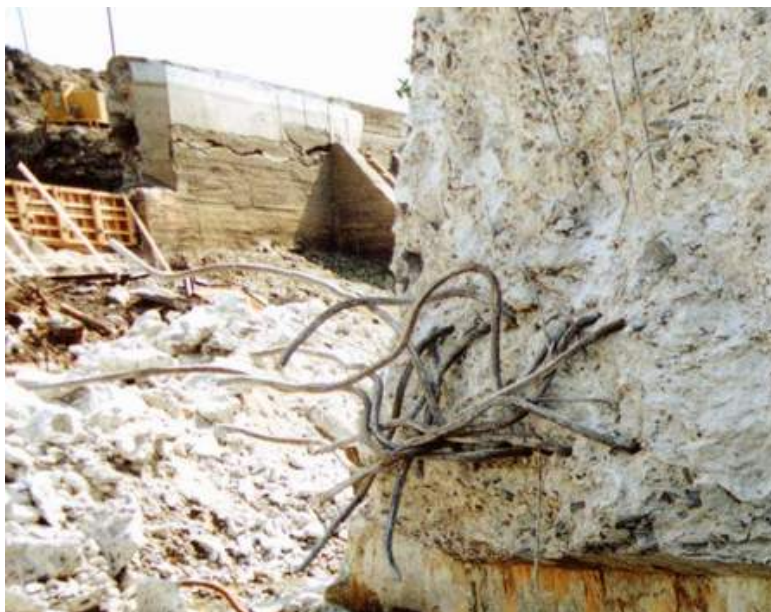
Figure 8: Exposed 100 year old rebar anchors

At a project in Glens Falls, NY, one inch square bars embedded in limestone with cement grout were installed about 100 years ago to anchor the sluiceways of a dam. Ice forces and high water flows had led to severe deterioration of the concrete structure. As shown in Figure 8, many of the dowels were bent, twisted and even broken off, however, all appeared quite serviceable and none were noted to have either pulled out of the rock or rusted off.
