# **A Recommended Practice for Condition Assessment of Ground Anchors and Soil Nails**

### **GEO Construction Quality Assurance/Quality Control Technical Conference**

**November 6-9, 2005  
Dallas/Ft. Worth Texas**

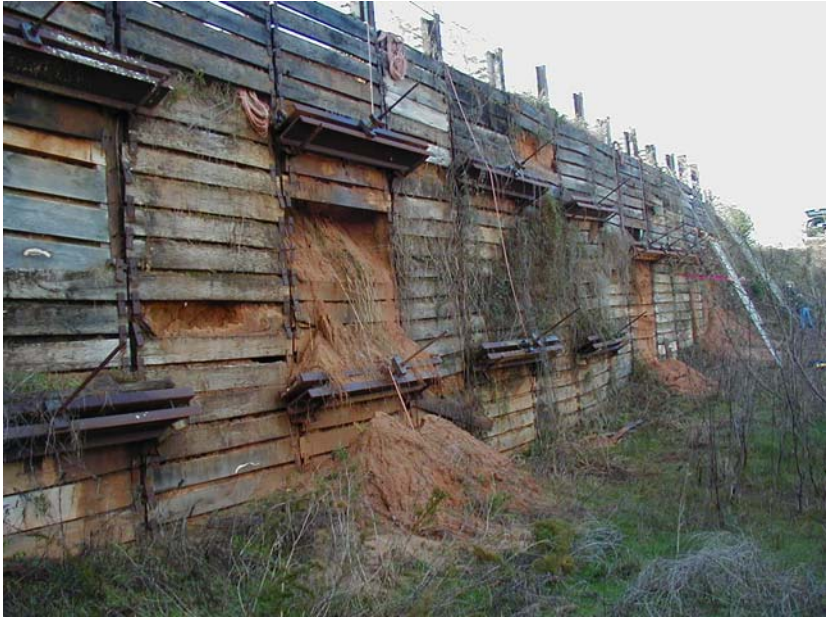
In 1991, a tied-back soldier pile wall with wood lagging (pictured in Figure 1) was constructed at the Texas A&M University-National Geotechnical Engineering Experimentation Site (TAMU-NGES). Soils at the site consist primarily of alluvial sand deposits. Based on the results from the chemical analysis, including pH close to neutral, and a relatively high resistivity, the soil at this site is not considered aggressive relative to corrosion.

Figure 1. Tieback Wall at TAMU-NGES

Briaud et al. (1998) report details of the wall construction and performance monitoring during and after construction. Tiebacks are 32 mm diameter, Grade 1035, Dywidag bars which were installed in 89 mm diameter holes. Bonded lengths are 7.3 m, and unbonded lengths are either 4.6 m or 4.9 m, depending on location. All anchors were installed 30° to the horizontal, and pressure grouted in the bonded zone under pressures ranging between 1.4 MPa and 4.1 MPa. Grease and a plastic sheath surrounded the elements in the unbonded zone. The wall was instrumented with strain gauges, load cells, and inclinometers. Generally, load cells indicated relatively constant anchor loads over the five-year period during which the wall behavior was studied.

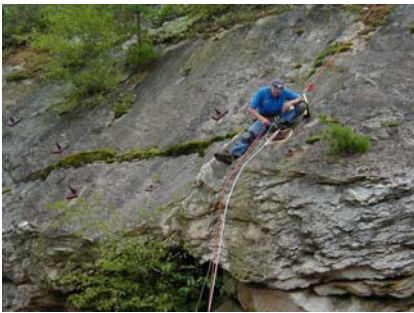
Figure 3. Simple Impact Test

Both simple impact testing and GRANIT testing were performed on prestressed rock bolts as depicted in Figures 3 and 4. Damping, or the rate of decay, of the acceleration amplitude response has been shown to increase with respect to level of prestress for rock bolts (Rodger, et al., 1997). The envelop of the positive peaks of the amplitude response over the initial portion of the acceleration time history (damping envelop) portrays the rate of decay as shown in Figures 5 (a) and (b). Loss of prestress is diagnosed from NDT by comparing the rates of decay observed for the sample population and identifying rock bolts associated with relatively low rates of decay as having an apparent loss of prestress. Thus, NDT results are described qualitatively in terms of “Good” or no apparent loss of prestress, or no good, “NG”, corresponding to an apparent loss of prestress. Table 3 is a summary of lift off test results and comparison with the interpretation from NDT.

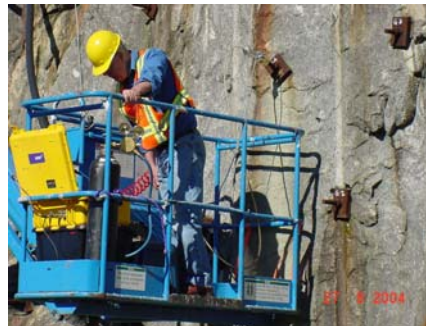
Figure 4. GRANIT Test

Reasonable agreement was recognized between results of lift-off tests and NDT. In general, the results indicate that a high percentage of the rock bolts have suffered loss of prestress. The comparison between NDT and lift-off test results is favorable for between 63% (5 of 8) and 88% (7 of 8) of the measurements. Some ambiguity exists with respect to interpretation of NDT results when an intermediate level of prestress remains, and this is apparent in the interpretation of results for Bolt #7. Large losses of prestress, or, at the other extreme, rock bolts with the majority of prestress remaining, were correctly identified from the results of NDT. Results from GRANIT testing also identified bolts with low versus high levels of prestress. However, diagnosis of the magnitude of prestress from the results of GRANIT tests was not possible at this site due to ambiguity

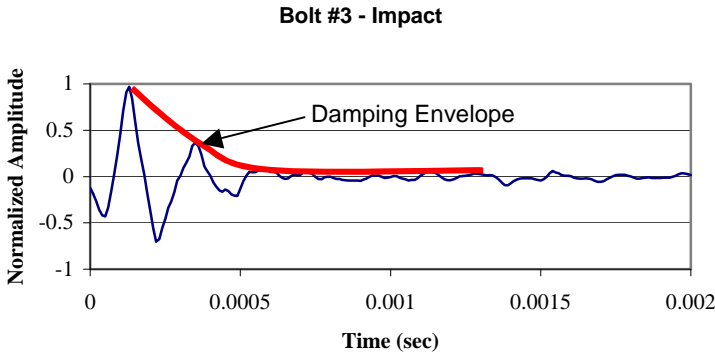
Figure 5 (a) High rate of decay indicative of relatively high bolt load.

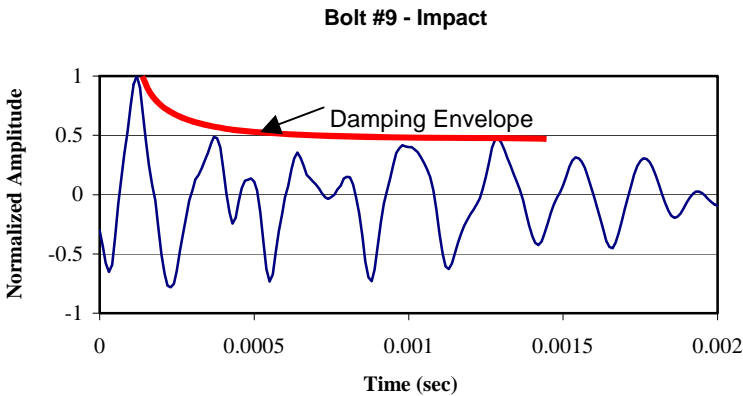
Figure 5 (b) Low rate of decay indicative of prestress loss.
